# Isothermal Fatigue, Damage Accumulation, and Life Prediction of a Woven PMC

Andrew L. Gyekenyesi  
Cleveland State University, Cleveland, Ohio

Prepared under Grant NAS3-1543

This dissertation focuses on the characterization of the fully reversed fatigue behavior exhibited by a carbon fiber/polyimide resin, woven laminate at room and elevated temperatures. Nondestructive video edge view microscopy and destructive sectioning techniques were used to study the microscopic damage mechanisms that evolved. The elastic stiffness was monitored and recorded throughout the fatigue life of the coupon and later utilized as a damage variable for a phenomenological model. In addition, residual compressive strength tests were conducted on fatigue coupons with various degrees of damage as quantified by stiffness reduction. Experimental results indicated that the monotonic tensile properties were only minimally influenced by temperature, while the monotonic compressive and fully reversed fatigue properties displayed noticeable reductions due to the elevated temperature. The stiffness degradation, as a function of cycles, consisted of three stages; a short-lived high degradation period, a consta

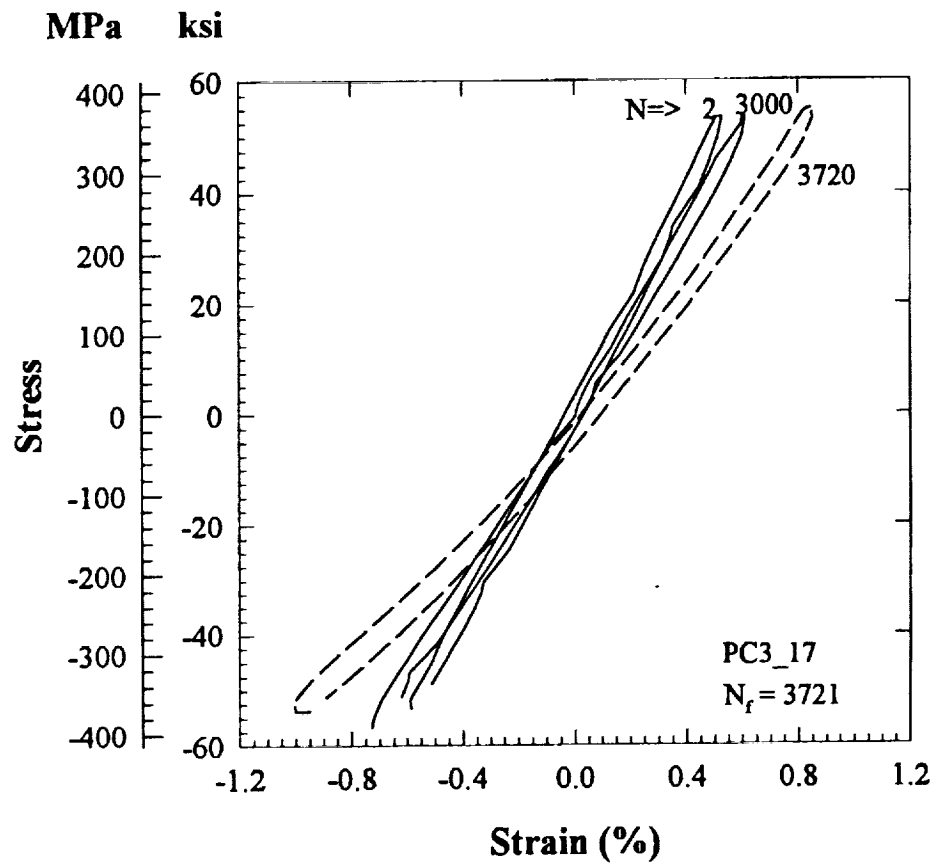
**Figure 3.12** Fatigue deformation response of T650-35/PMR15 16-ply (0/90) weave at 22°C (72°F):  $\sigma_{max} = 379$  MPa (55 ksi).

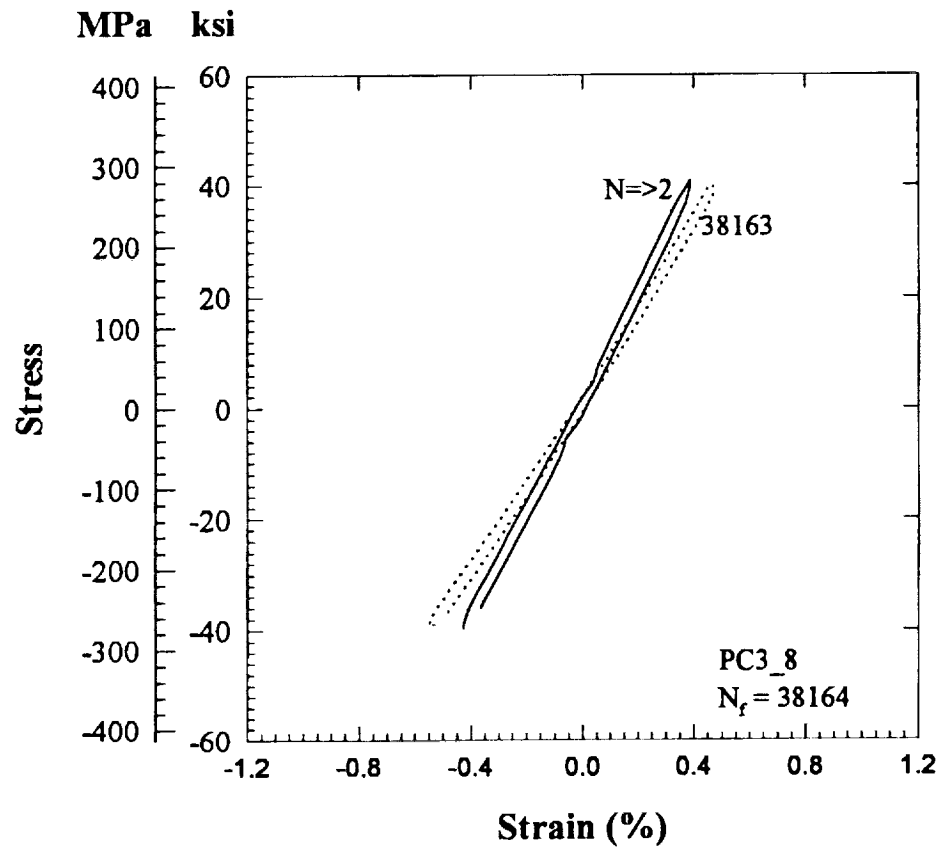
**Figure 3.13** Fatigue deformation response of T650-35/PMR15 16-ply (0/90) weave at 316°C (600°F):  $\sigma_{max} = 276$  MPa (40 ksi).

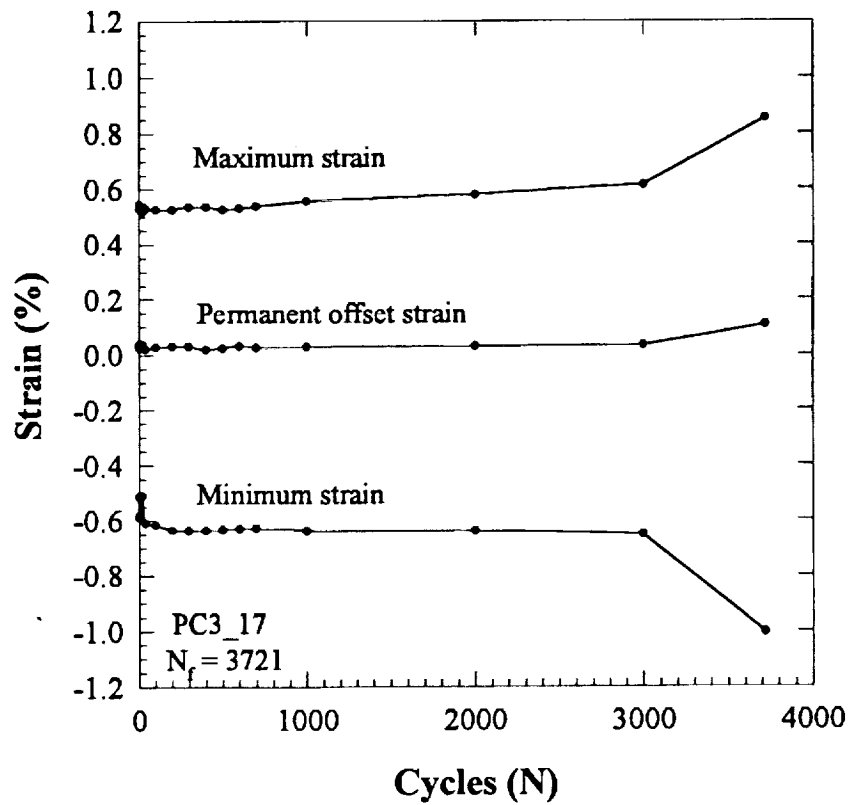
**Figure 3.14** Fatigue strain behavior of T650-35/PMR15 (0/90) at 22°C (72°F):  $\sigma_{max} = 379$  MPa (55 ksi).

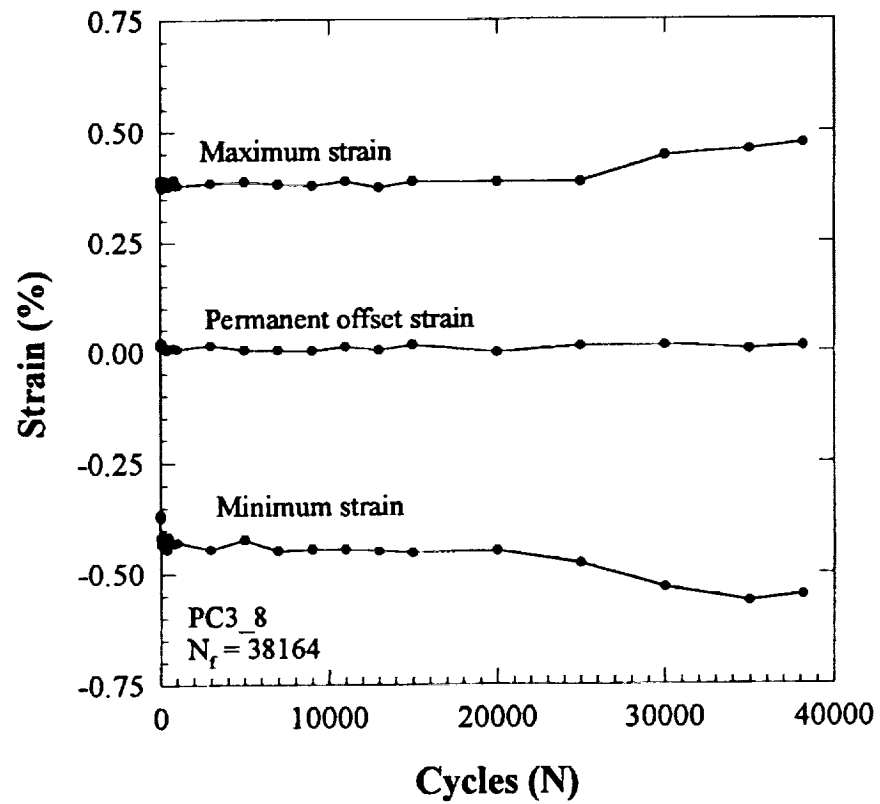
**Figure 3.15** Fatigue strain behavior of T650-35/PMR15 (0/90) at 316°C (600°F)  
 $\sigma_{max} = 276$  MPa (40 ksi).

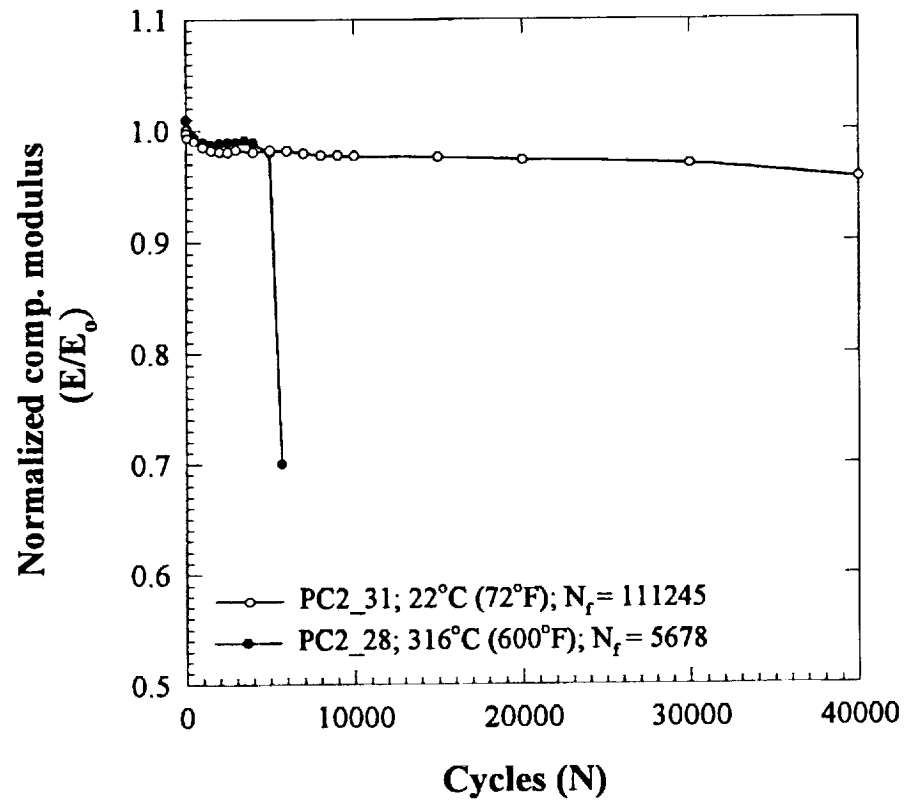
**Figure 3.16** Comparison of modulus degradation behavior between 22°C (72°F) and 316°C (600°F) at an equivalent maximum stress:  $\sigma_{max} = 310$  MPa (45 ksi).

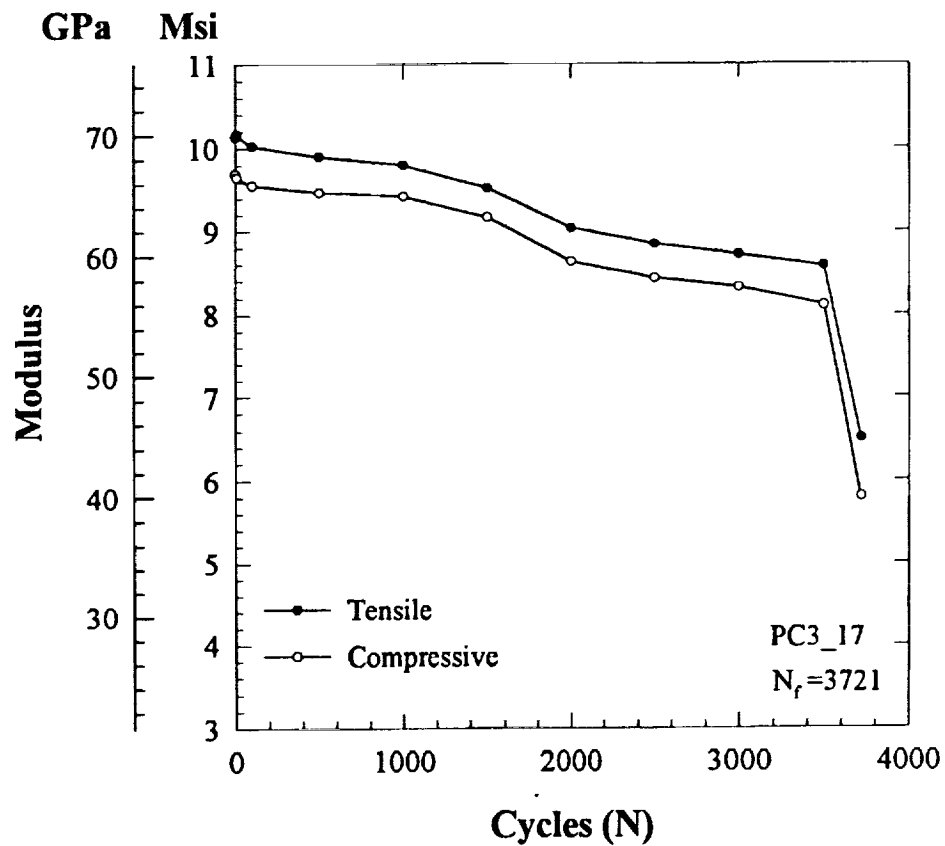
**Figure 3.17** Typical degradation of tensile and compressive moduli during isothermal fatigue at 22°C (72°F):  $\sigma_{max} = 379$  MPa (55 ksi).

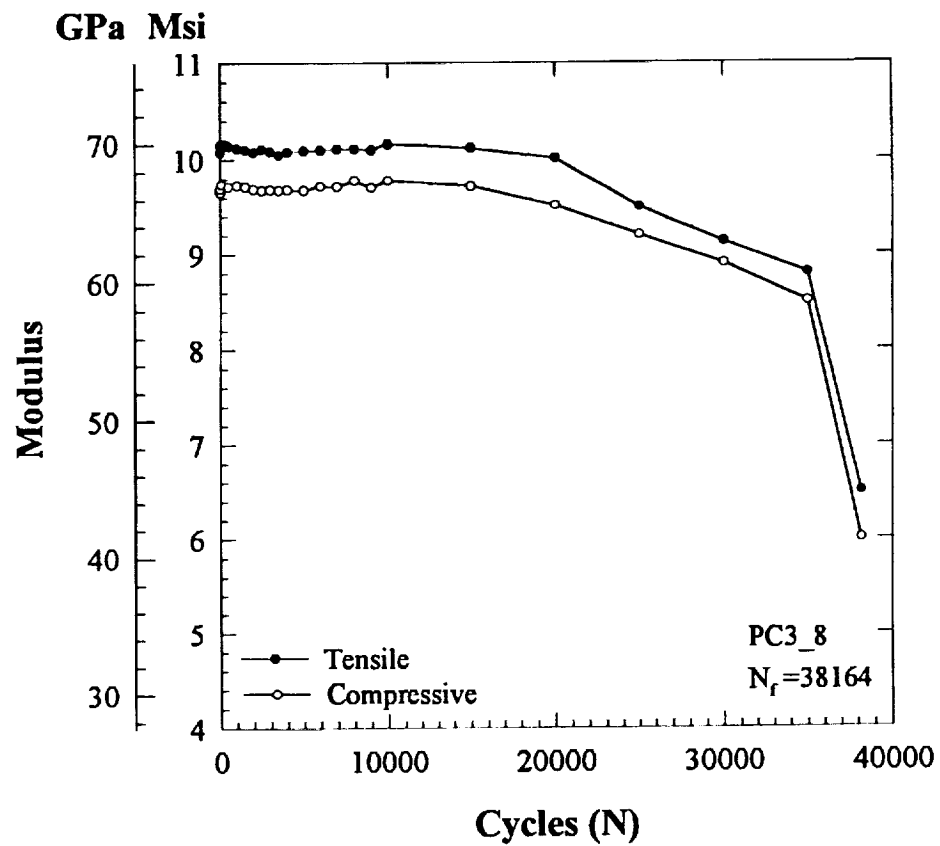
**Figure 3.18** Typical degradation of tensile and compressive moduli during isothermal fatigue at 316°C (600°F):  $\sigma_{max} = 276$  MPa (40 ksi).

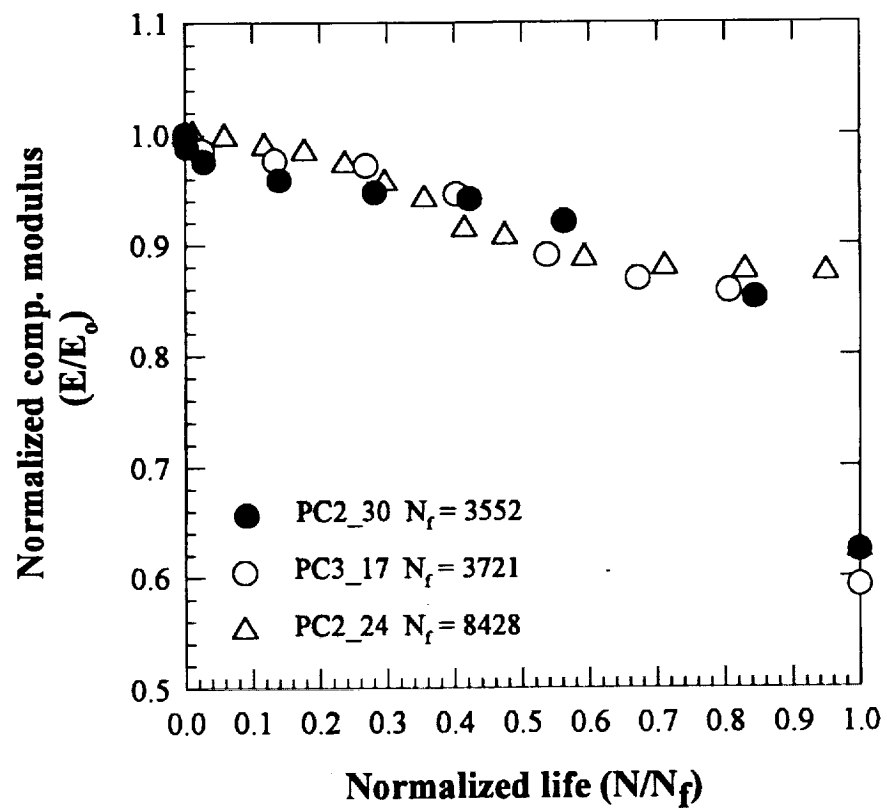
**Figure 3.19** Normalized compressive modulus degradation behavior for multiple specimens at 22°C (72°F):  $\sigma_{max} = 379$  MPa (55 ksi).

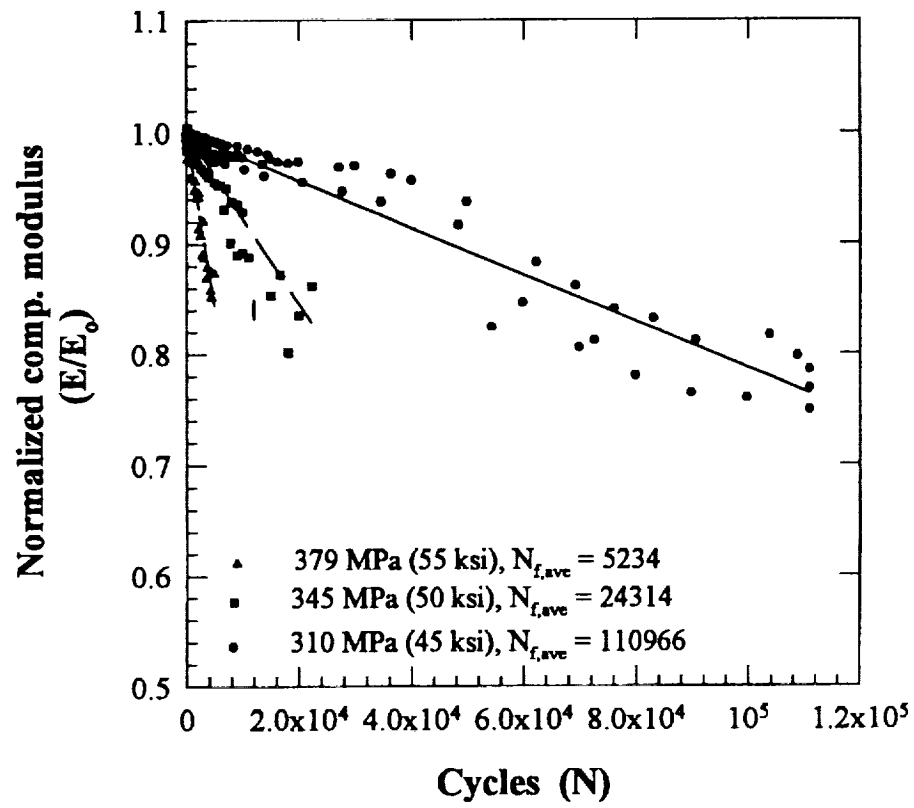
**Figure 3.20** Normalized compressive modulus degradation behavior at various cyclic loads for 22°C (72°F) condition. For clarity, Stage III is not shown.

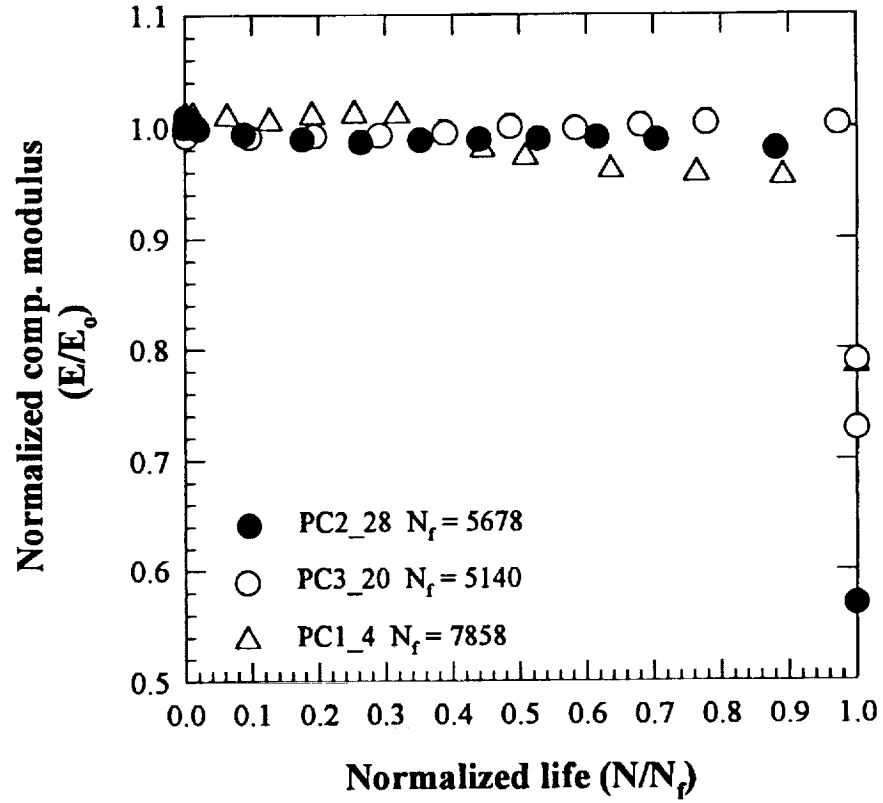
**Figure 3.21** Normalized compressive modulus degradation behavior for multiple specimens at the 316°C (600°F):  $\sigma_{max} = 310$  MPa (45 ksi).

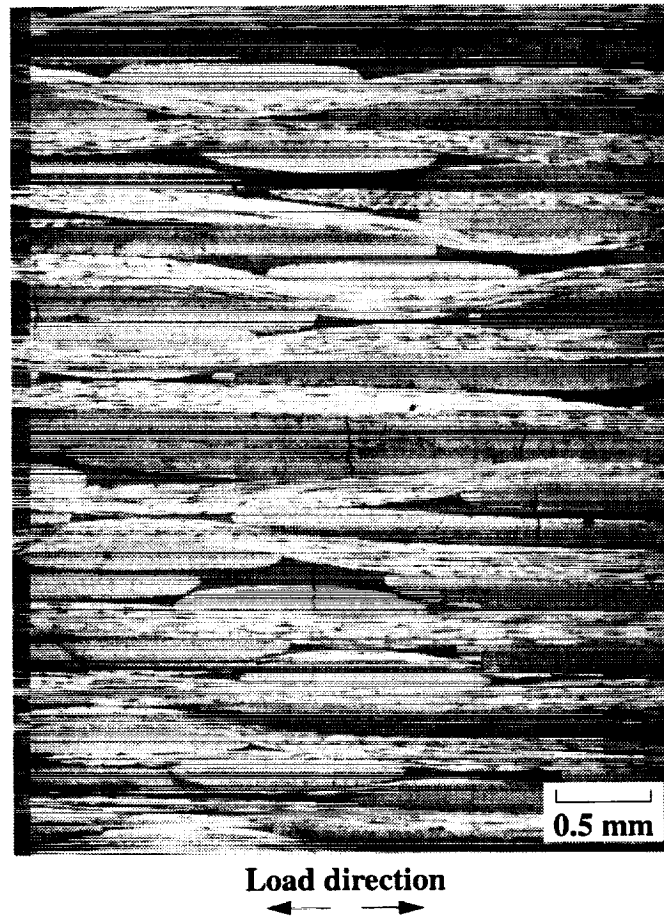
**Figure 3.22** Edge view of transverse cracks as observed by microstructural examination of 22 °C (72 °F) specimen with 1% stiffness reduction (view #2; see Figure 2.7): 25x magnification:  $\sigma_{max} = 379$  MPa (55 ksi);  $N_{interrupt} = 208$ ; Specimen PC3\_10.

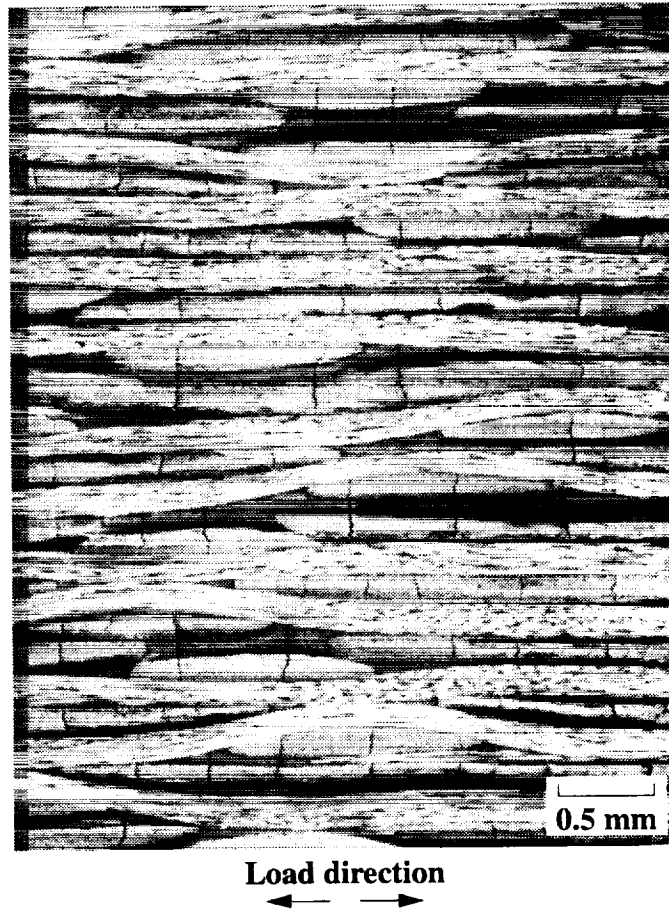
**Figure 3.23** Edge view of transverse cracks as observed by microstructural examination of 22 °C (72 °F) specimen with 5% stiffness reduction (view #2; see Figure 2.7): 25x magnification;  $\sigma_{max} = 379$  MPa (55 ksi);  $N_{interrupt} = 3120$ ; Specimen PC2\_10.

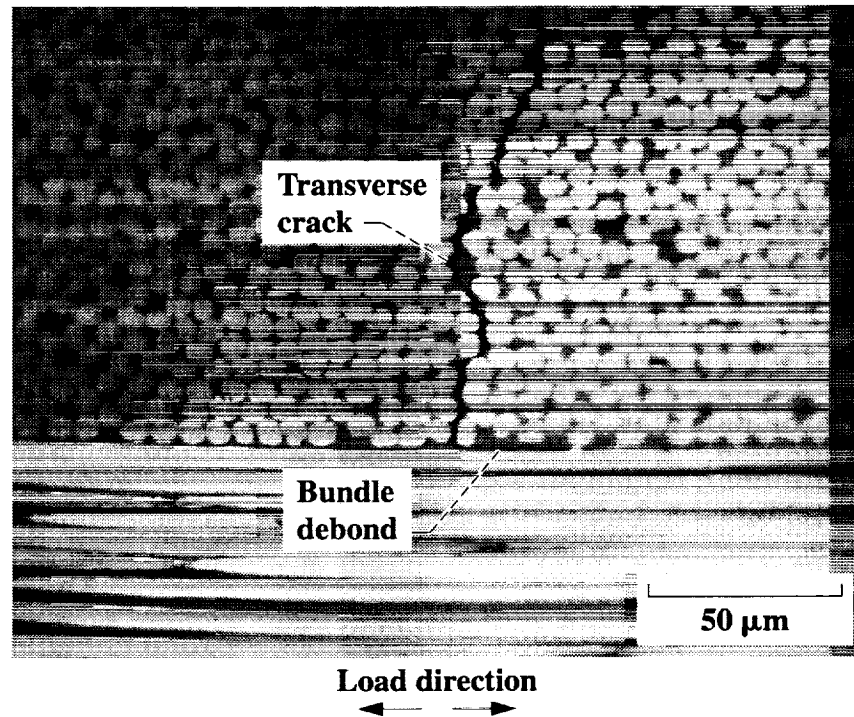
**Figure 3.24** Edge view of transverse crack tip and initiation of bundle debond as observed by microstructural examination of 22 °C (72 °F) specimen with 5% stiffness reduction. (view #2; see Figure 2.7): 500x magnification;  $\sigma_{max} = 379$  MPa (55 ksi);  $N_{interrupt} = 3120$ ; Specimen PC2\_10.

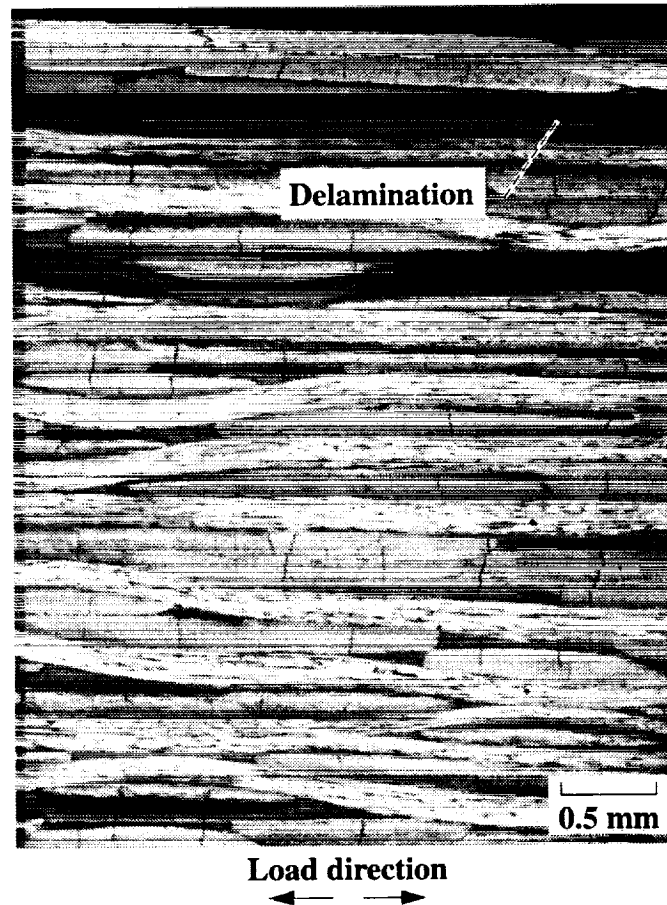
**Figure 3.25** Edge view of transverse cracks and interply delamination as observed by microstructural examination of 22 °C (72 °F) specimen with 11% stiffness reduction. (view #2; see Figure 2.7): 25x magnification:  $\sigma_{max} = 379$  MPa (55 ksi);  $N_{interrupt} = 3010$ ; Specimen PC3\_25.

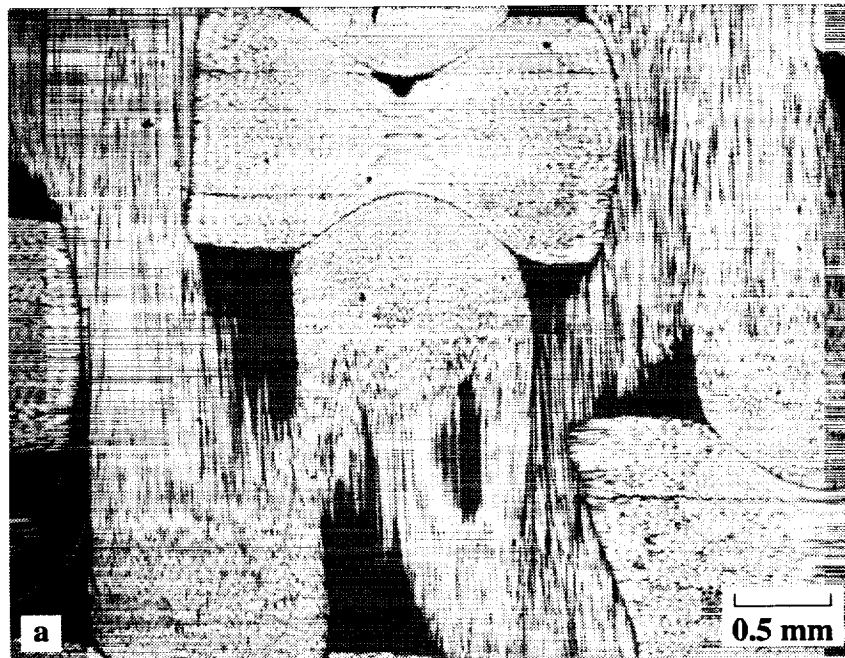
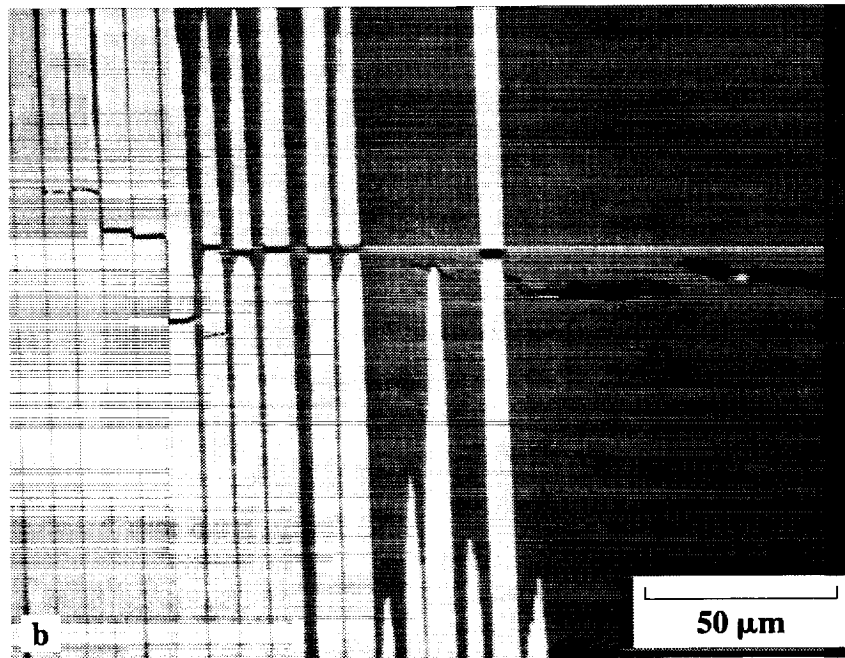
**Figure 3.26** Transverse cracks as observed from the polished face of a 22 °C (72 °F) specimen with 11% stiffness reduction. (view #4; see Figure 2.7): (a) 25x magnification. (b) Showing fiber breaks at 500x magnification:  $\sigma_{max} = 379 \text{ MPa}$  (55 ksi);  $N_{interrupt} = 3010$ ; Specimen PC3\_25.

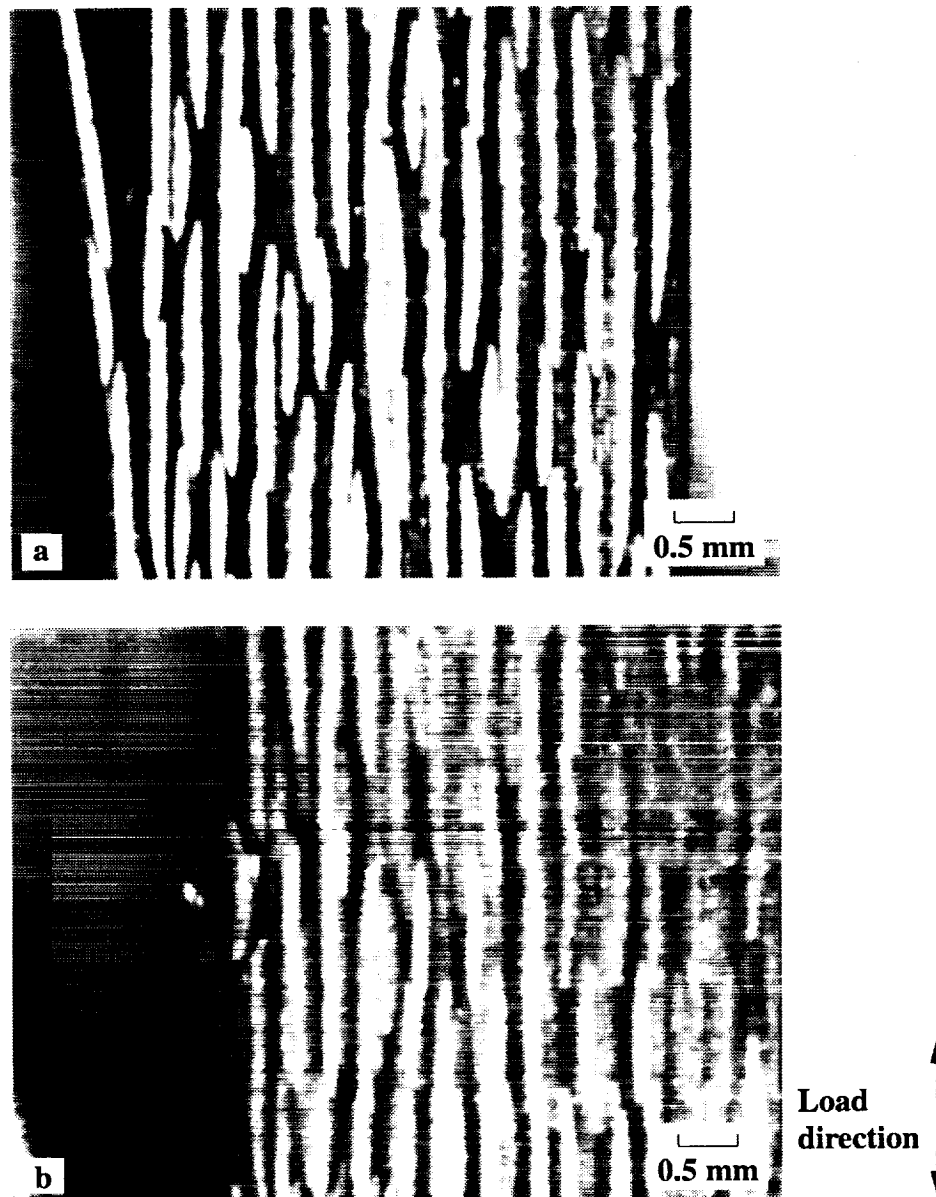
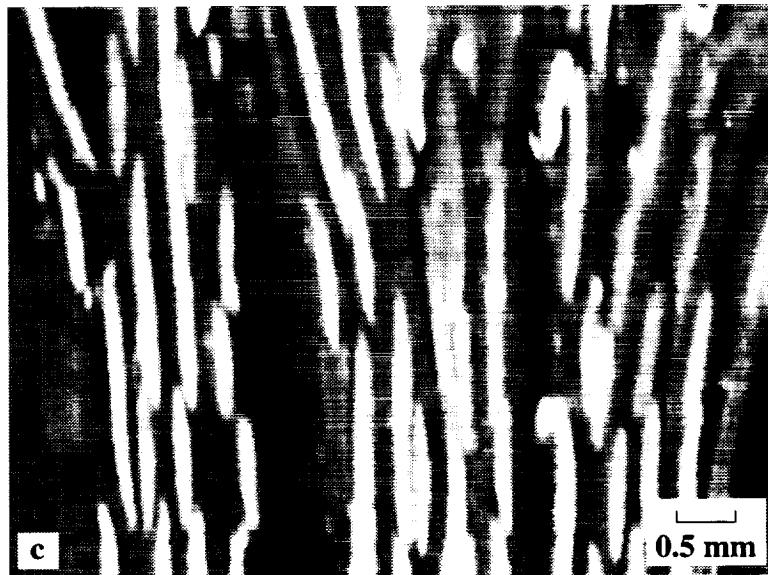
**Figure 3.27** Damage progression as observed by in-situ edge view of 22 °C (72 °F) specimen at 15x magnification. (a) Delamination at cycle 1800. (b) Inward growth of delamination and buckling of isolated bundle at cycle 2300. (c) Failure in compression due to massive bundle debonding and buckling:  $\sigma_{max} = 414$  MPa (60 ksi); Specimen PC3\_32;  $N_f = 2426$ .

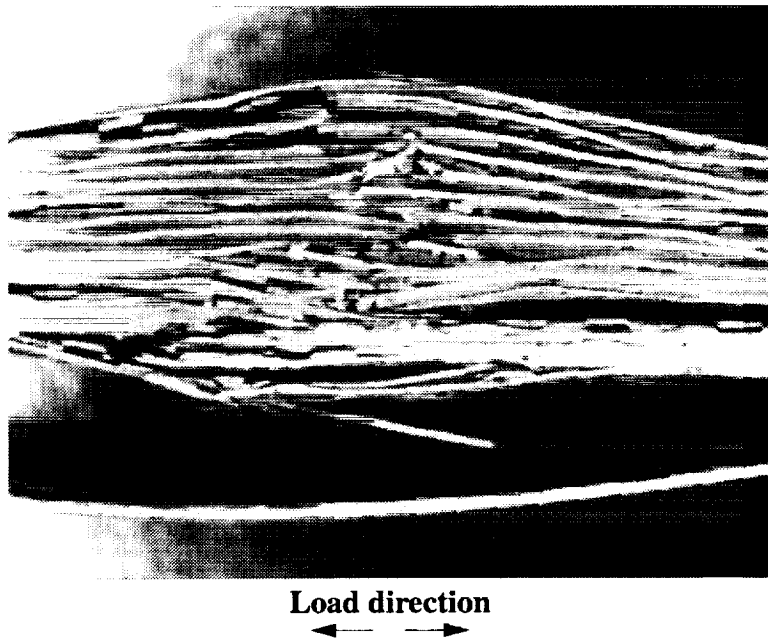
**Figure 3.28** Post failure view of 22 °C (72 °F) specimen at 7.5x magnification. Specimen PC3\_32.

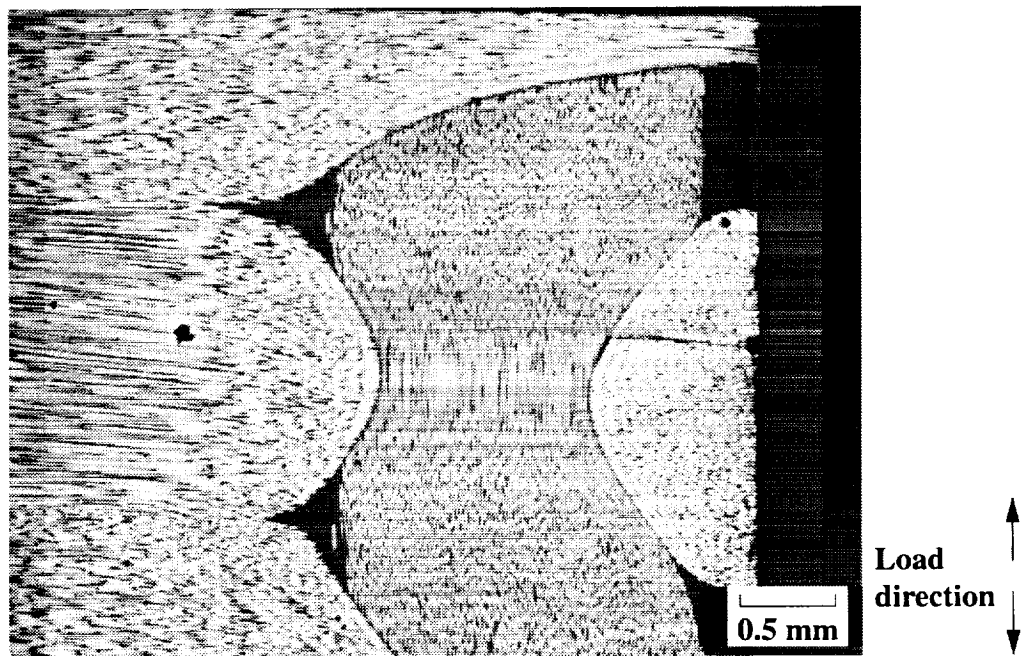
**Figure 3.29** Face view showing penetration of transverse cracks as observed by microstructural examination of 316 °C (600 °F) specimen with 5% stiffness reduction. (view #4; see Figure 2.7): 25x magnification;  $\sigma_{max} = 276$  MPa (40 ksi);  $N_{interrupt} = 130000$ ; Specimen PC4\_4.

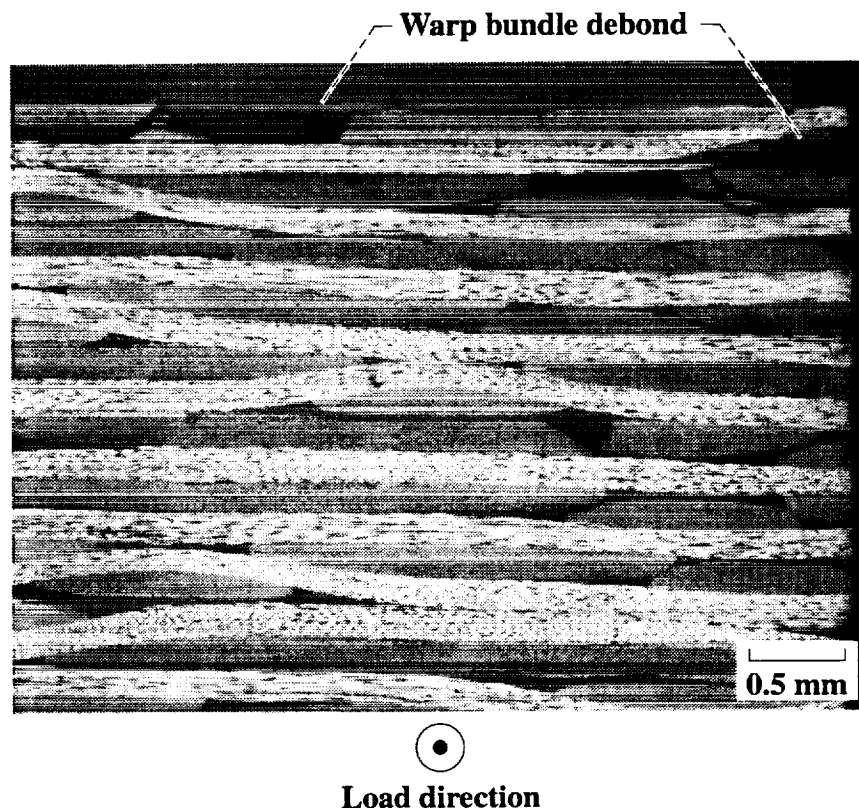
**Figure 3.30** Bundle debonds along the face and edge at 25x magnification as seen from longitudinal loading axis (view #1) obtained from microstructural examination of 316 °C (600 °F) specimen with 5% stiffness reduction:  $\sigma_{max} = 276$  MPa (40 ksi);  $N_{interrupt} = 130000$ ; Specimen PC4\_4.

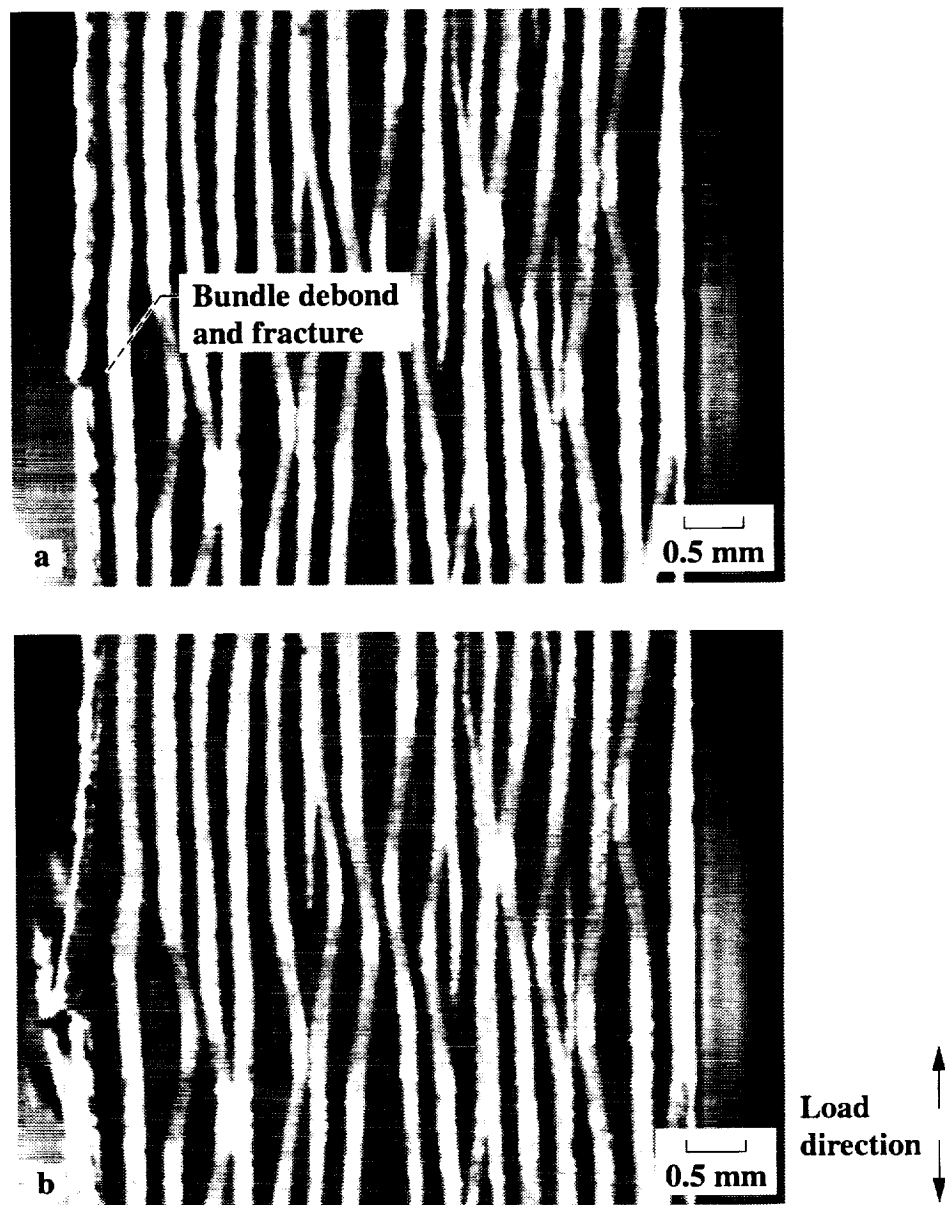
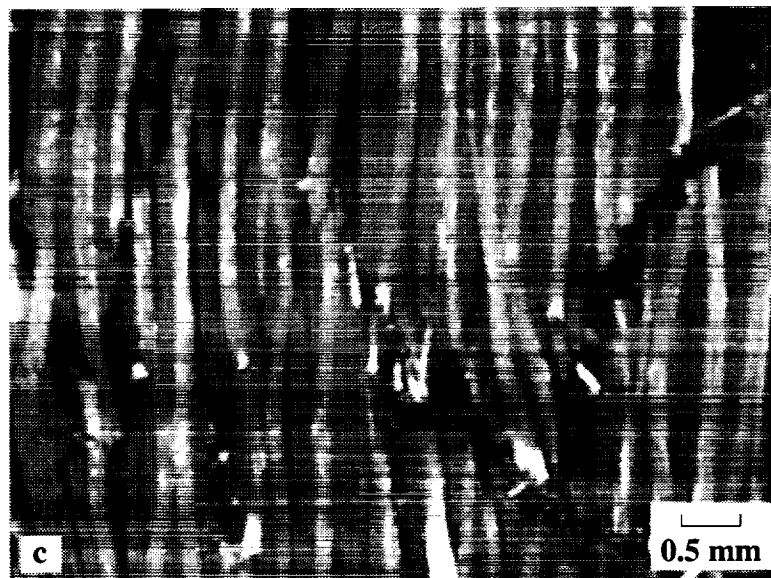
**Figure 3.31** Damage progression as observed by in-situ edge view of 316 °C (600 °F) specimen at 15x magnification. (a) Warp bundle debond and fracture due to buckling at cycle 3200. (b) Interply delamination and inward growth of debonds at cycle 7200. (c) Failure due to massive bundle debonding and buckling:  $\sigma_{max} = 310 \text{ MPa}$  (45 ksi); Specimen PC1\_4;  $N_f = 7858$ .

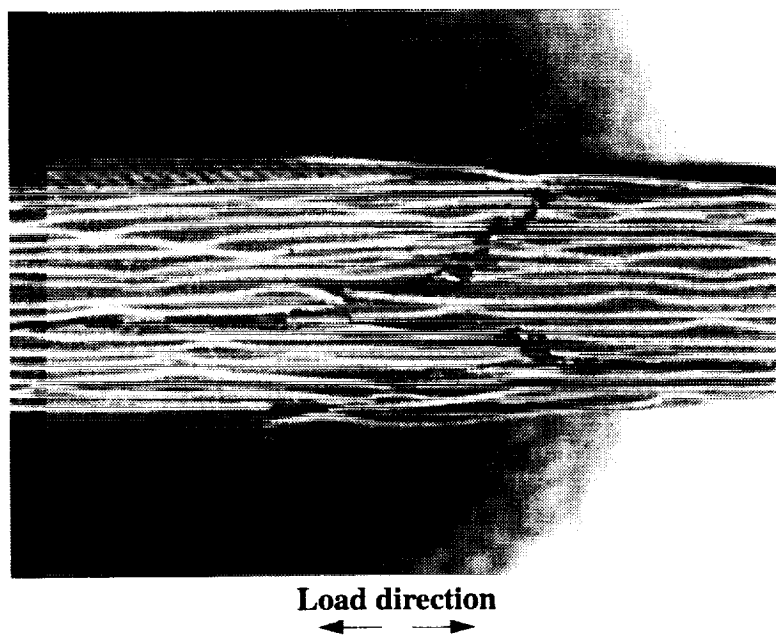
**Figure 3.32** Post failure view of 316 °C (600 °F) specimen at 7.5x magnification: Specimen PC3\_20.

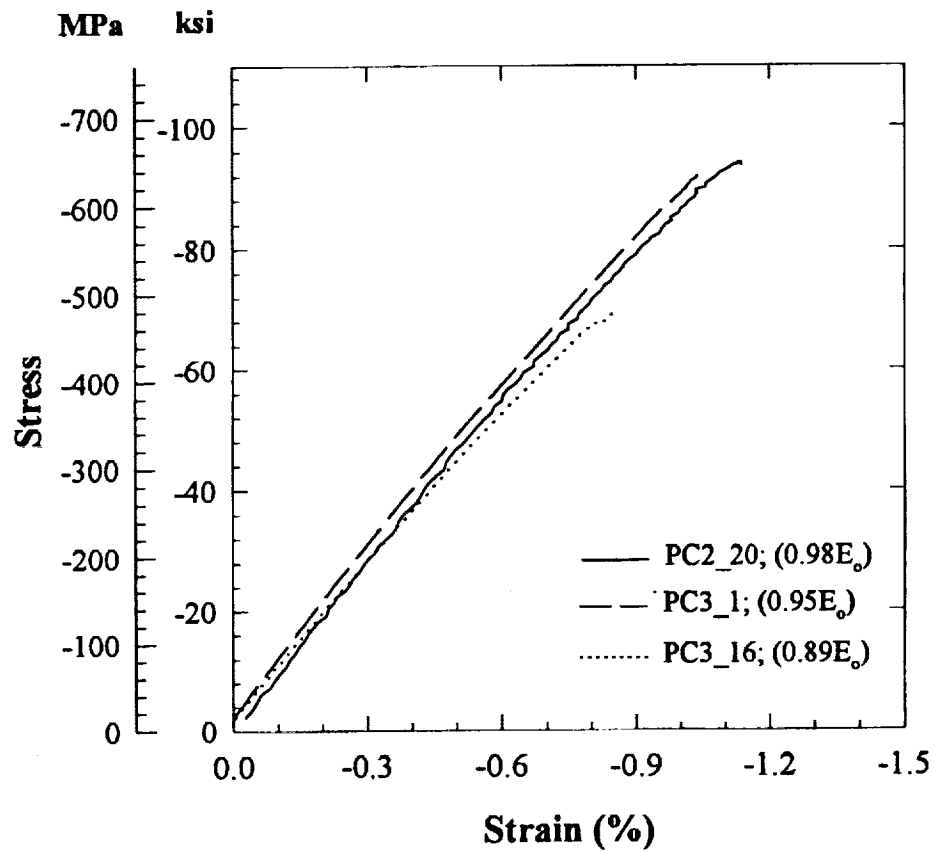
**Figure 3.33** Residual compressive strength behavior for three damage levels. Fatigue and residual strength tests conducted at 22°C (72°F): Fatigued at  $\sigma_{max} = 310$  MPa (45 ksi).

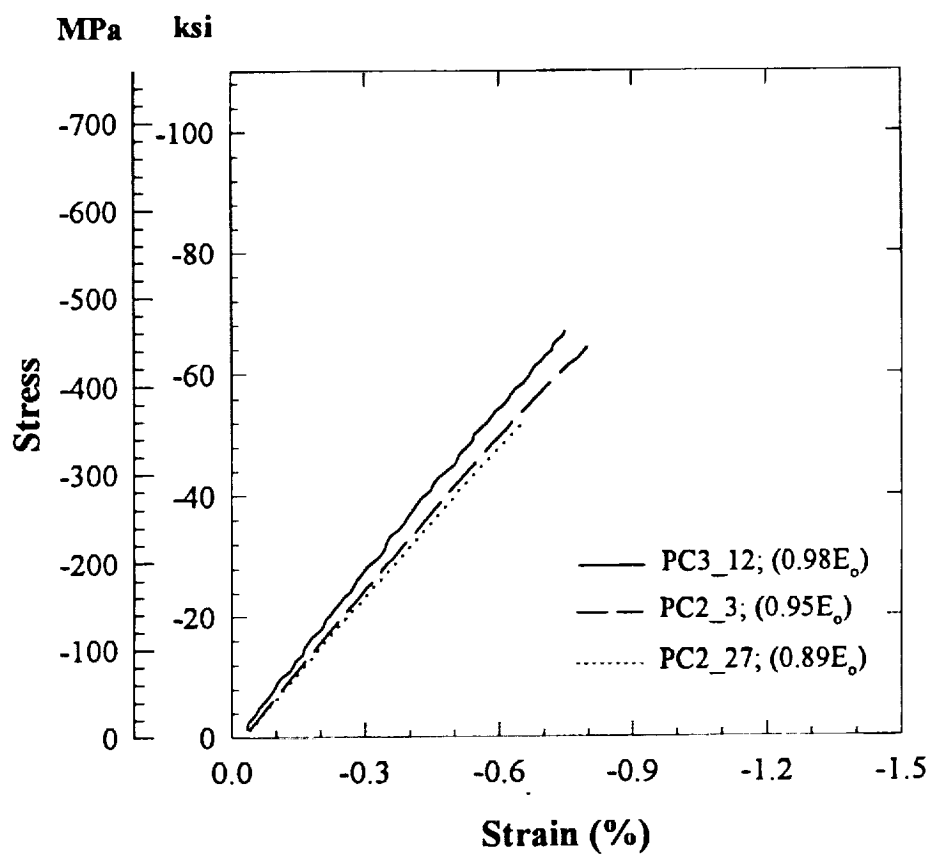
**Figure 3.34** Residual compressive strength behavior for three damage levels. Fatigue and residual strength tests conducted at 316°C (600°F): Fatigued at  $\sigma_{max} = 276$  MPa (40 ksi).

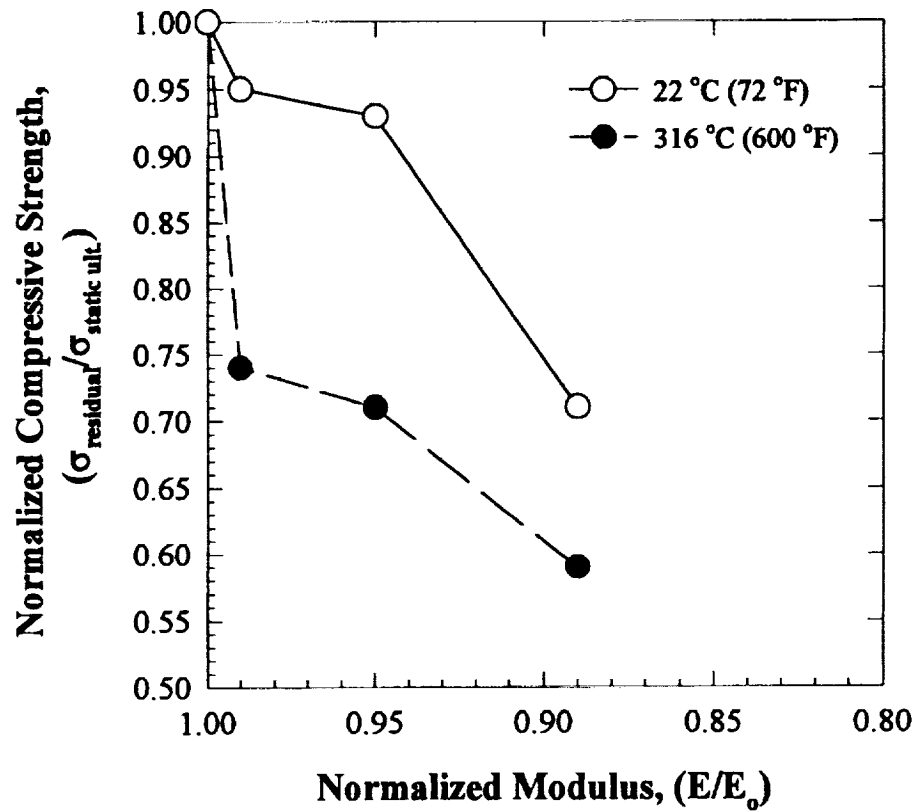
**Figure 3.35** Residual compressive strength behavior as a function of damage (i.e., modulus degradation).

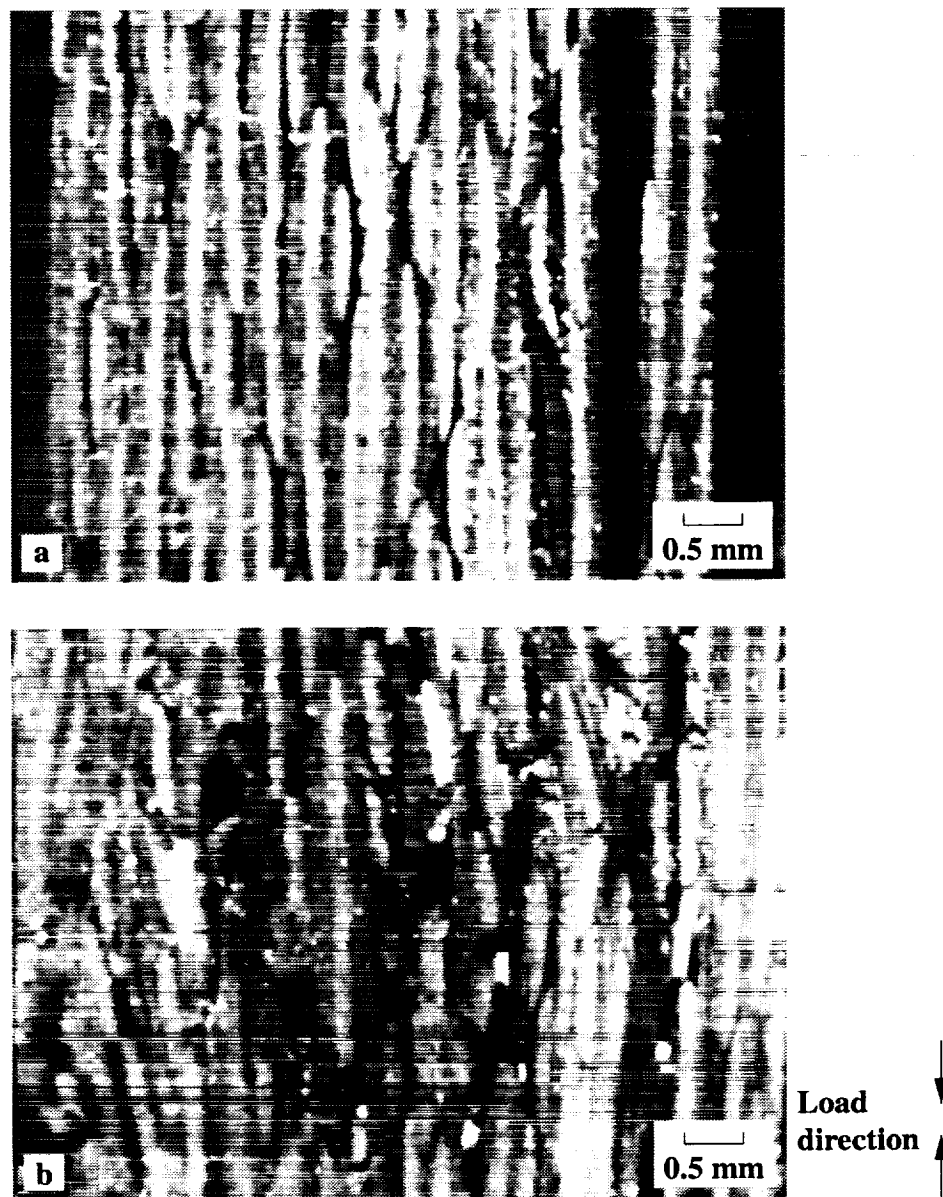
**Figure 3.36** Residual compression strength coupon at 22 °C (72 °F) as observed using video images of monitored edge view with 15x magnification. Initial damage state included a delamination induced by the fatigue test. (a) Image taken at -462 MPa (-67 ksi) right before failure. (b) Failure at -483 MPa (-70 ksi): Damage =  $0.89E_0$ ; Specimen PC3\_16c.

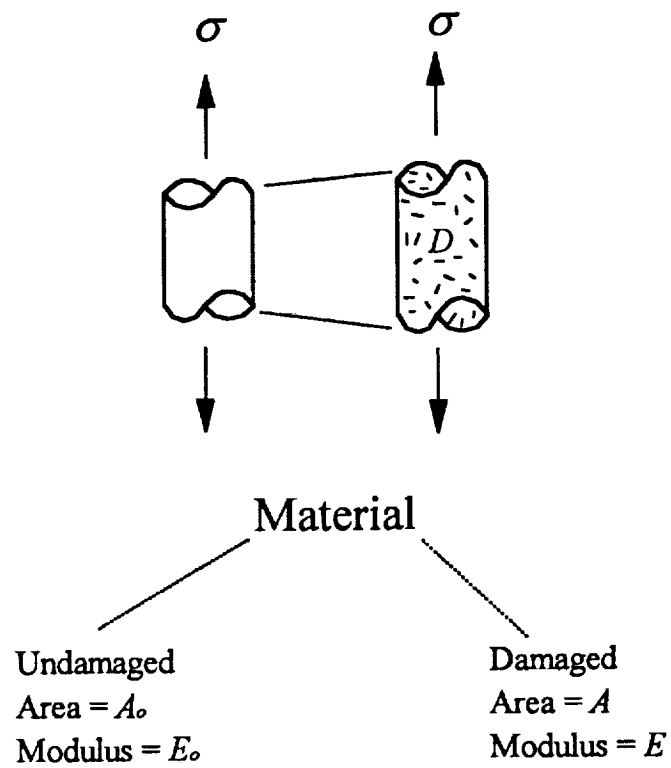
**Figure 4.1** Schematic of specimen with reduced stiffness as a result of damage.

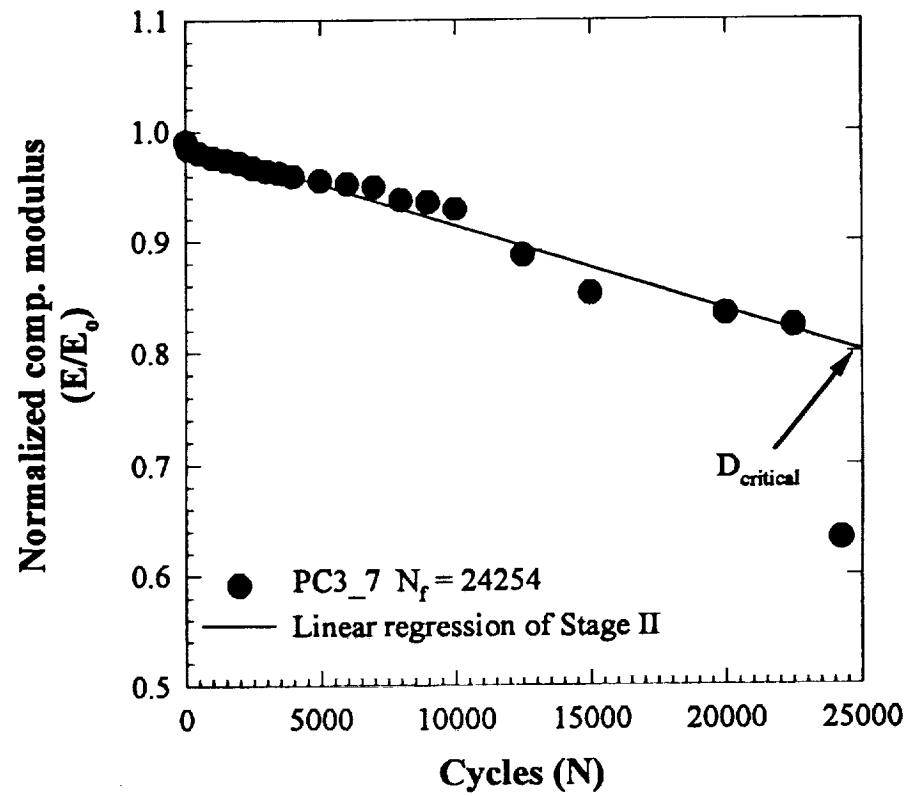
**Figure 4.2** Stage II linear regression curve fit for a typical compressive modulus plot at 22°C (72°F):  $\sigma_{Lmax} = 345$  MPa (50 ksi);  $\Phi = 0.403$ .
